Channel response to sediment release: insights from a paired analysis of dam removal

Mathias J. Collins^{1*}, Noah P. Snyder², Graham Boardman³, William S.L. Banks⁴,
Mary Andrews⁵, Matthew E. Baker⁶, Maricate Conlon⁷, Allen Gellis⁸, Serena
McClain⁹, Andrew Miller⁶, Peter Wilcock¹⁰

ABSTRACT

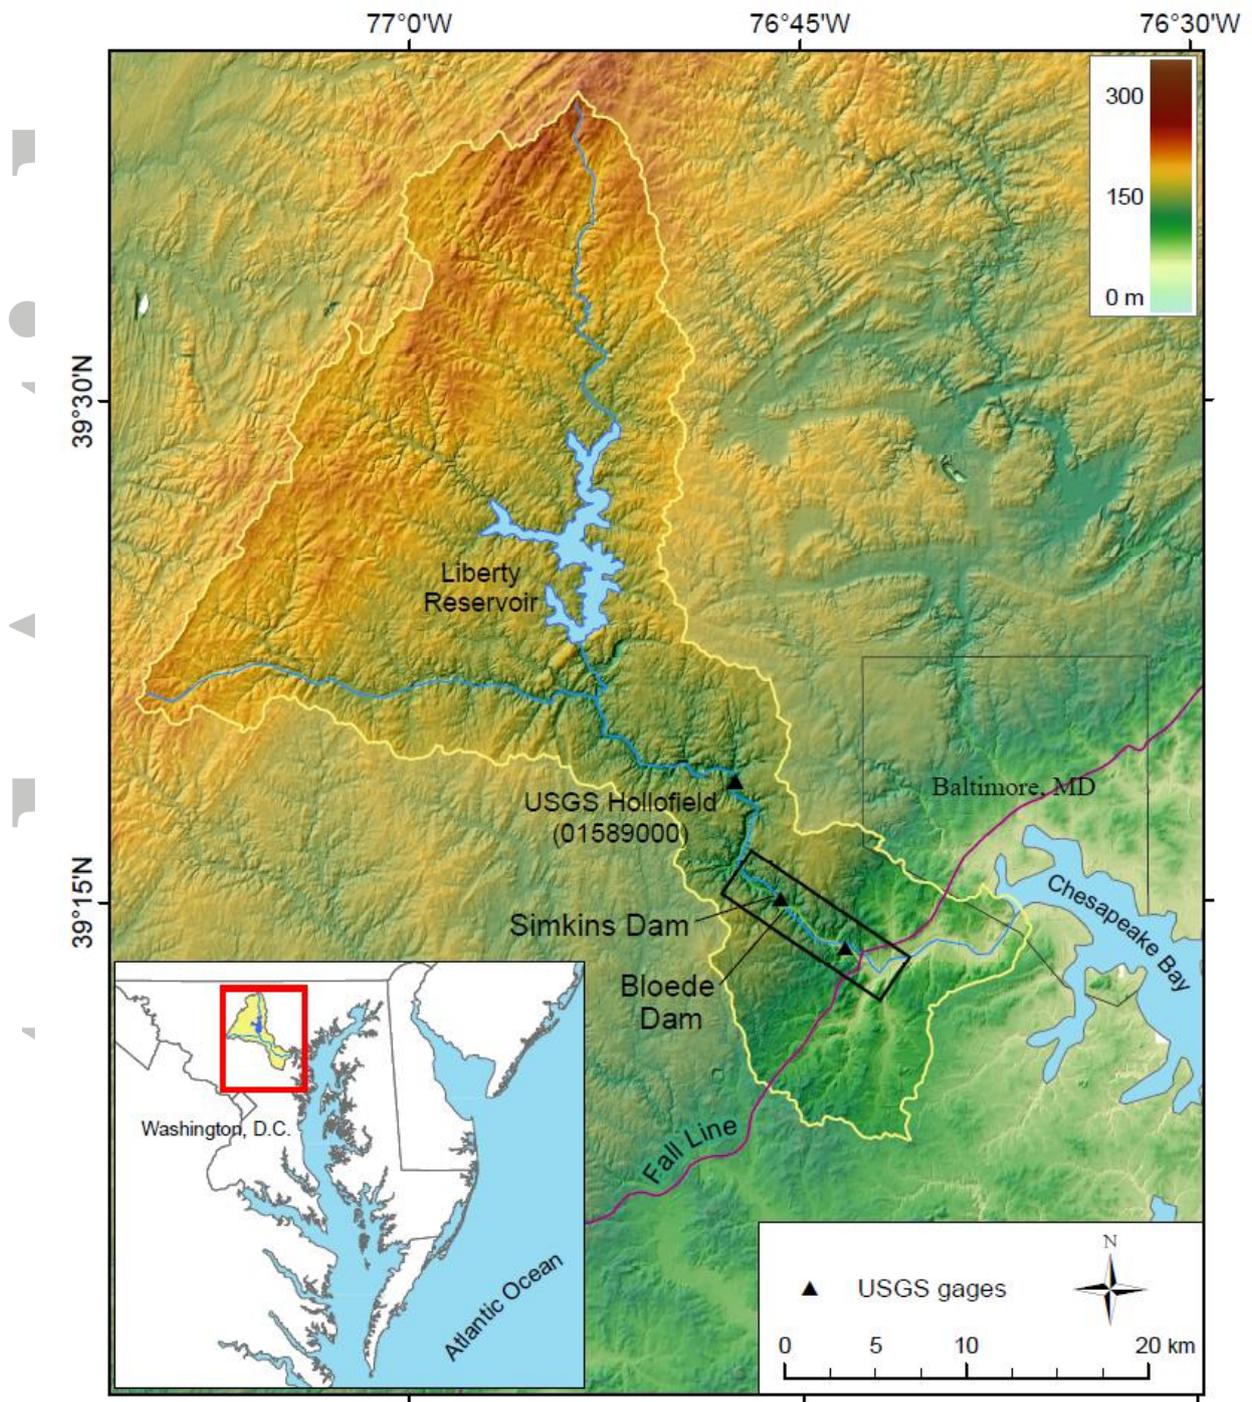
Figure 1: The Patapsco River watershed. Black extent rectangle delimits the Simkins Dam removal study area, detailed in Figure 3.

The Patapsco River drains a 950 km² watershed west of Baltimore, MD (Figure 1). Much of the basin is characterized by the rolling, dissected terrain of the Maryland Piedmont with maximum watershed elevations of about 300 m (*Hack, 1960; Smith and Wilcock, 2015*). Within our study area the Piedmont meets the Atlantic Coastal Plain at the Fall Line, an important regional physiographic contact where hydrogeomorphic characteristics change relatively abruptly. Above the Fall Line, the Patapsco River is gravel-bedded and flowing close to bedrock in a relatively steep, incised, and confined valley (*Costa, 1975; MDNRWS, 2005*). The channel bed gradients in free-flowing Piedmont reaches of our study area are about 0.002. Downstream in the Coastal Plain, the channel bed is lower gradient (0.0004), unconfined, and the sand-bedded Patapsco River channel is formed in unconsolidated Quaternary sediments that thicken away from the Fall Line to about 100 m thick where the river discharges to Chesapeake Bay (*Cleaves et al., 1968*;

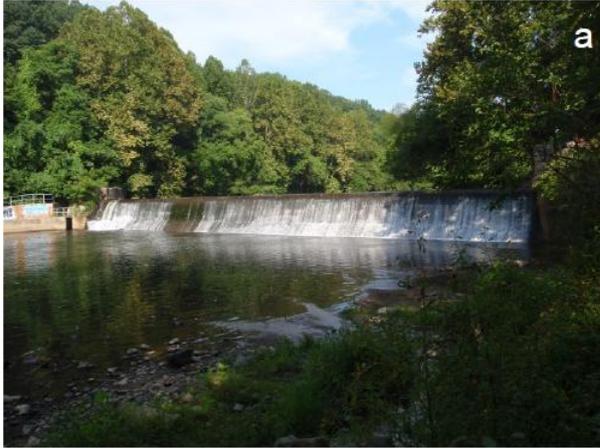
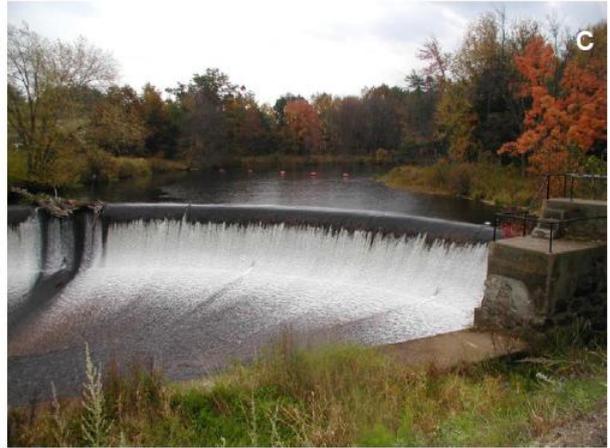
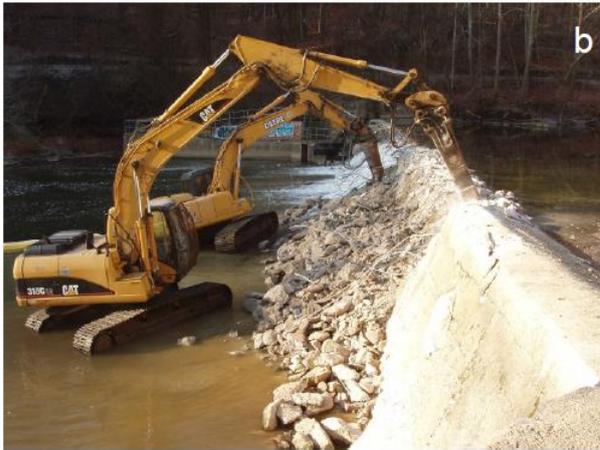
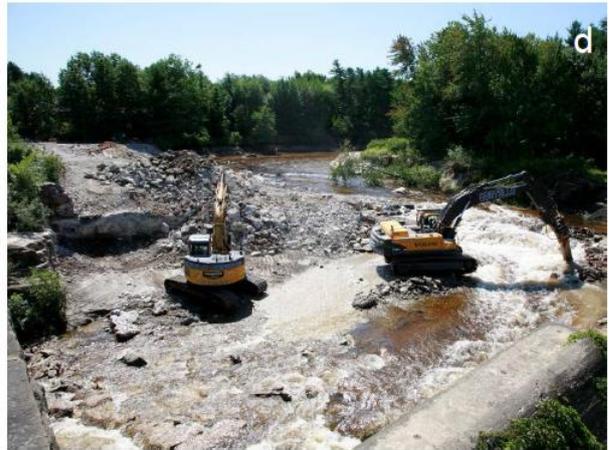
Figure 2: Simkins Dam before (a) and during (b) the late 2010 removal; Merrimack Village Dam (MVD) in 2003 (c) and during the 2008 removal (d).

The ~3 m high Simkins Dam was removed from the lower Patapsco River in late fall 2010 to improve public safety, aquatic habitat, and migratory fish passage (Figures 1 and 2, Table 1). An estimated 67,000 m³ of predominantly sand and some gravel in the former reservoir were released to the downstream reach that extends about 20 river km to Chesapeake Bay. The stored sediment quantity is based on estimates made by Interfluve, Inc. (unpublished data, 2009) and *Stillwater Sciences* (2010) from the geometry of the impoundment and assumptions about the pre-dam channel bed slope. Less than a kilometer downstream of Simkins Dam is the ~10 m high Bloede Dam with an impoundment that is filled with an estimated 240,000 m³ of predominantly sand and mud-sized sediments with some gravel (Figure 3a and b). The Bloede impoundment creates a low-gradient, depositional reach that is uncharacteristic of the Piedmont section below Simkins Dam. Planning for the removal of Bloede Dam and release of impounded sediments is ongoing.

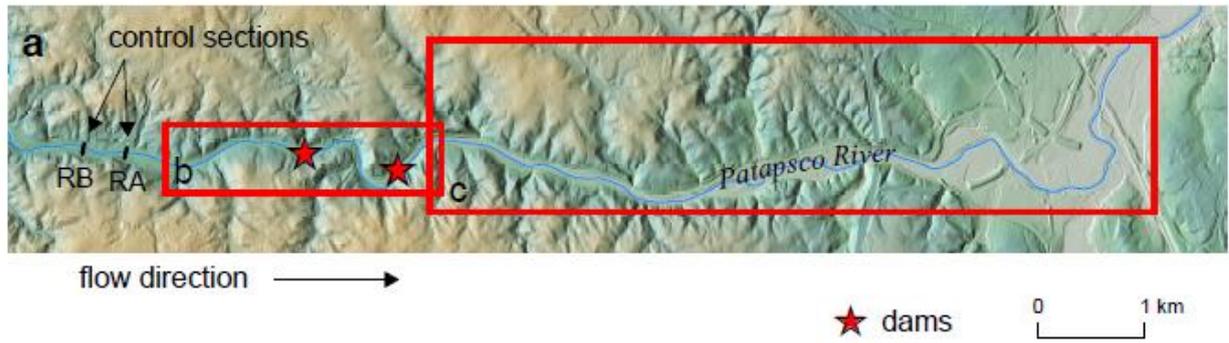
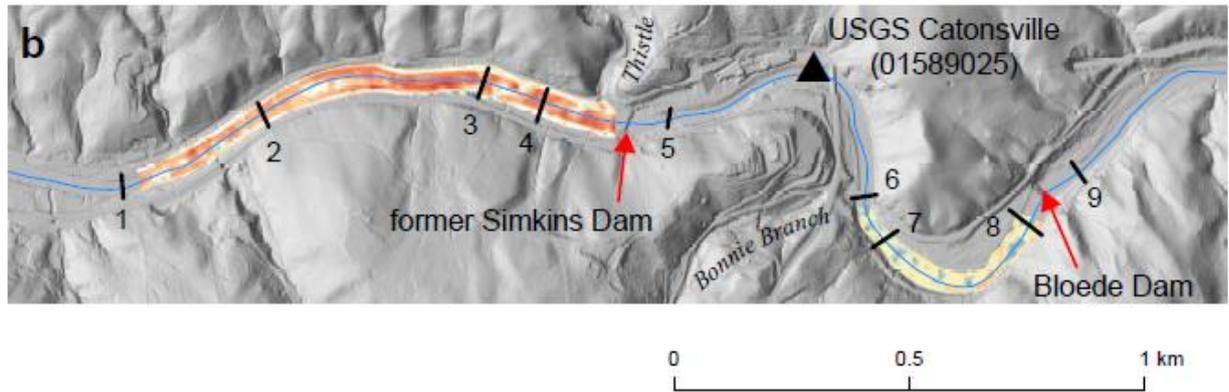
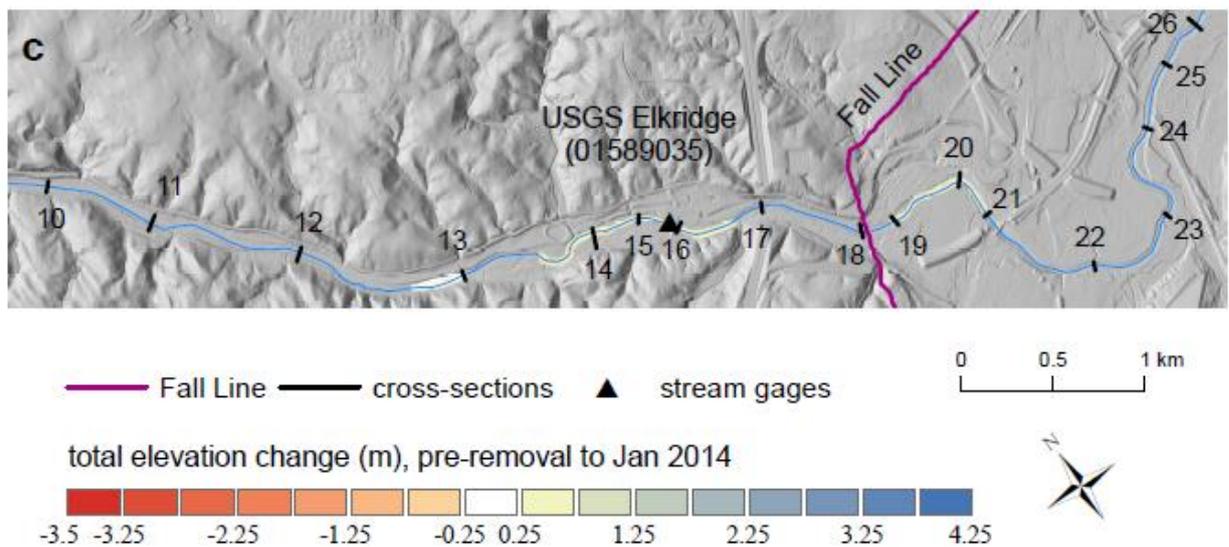
Figure 3: (a) Shaded relief of Patapsco study area showing extent rectangles for hillshades of (b) the upper study reach with the dam sites and (c) the lower reach where the channel transitions from comparatively steep (0.002) and confined in the Piedmont section to unconfined and low gradient (0.0004) in the Coastal Plain. Blue line is channel centerline approximated from pre-removal county lidar DEM mosaic. See Figure 1 for shaded relief elevation key.

We conducted repeat topographic and bathymetric surveys pre- and post-removal at 28 monumented cross-sections (Figure 3b and c and Figure 4). Two control sections, XS-RA and XS-RB, are above the Simkins impoundment (Figure

impoundment dewatering. Four samples were taken from an exposure on river left just upstream of the dam, both upstream and downstream of the Thistle Creek confluence (Figure 3b). The samples were obtained by driving a three-inch (~8 cm) diameter PVC ring flush with the surface. The ring was then carefully removed to prevent sediment loss and samples were placed in airtight bags to be transported to the laboratory where they were desiccated and weighed using a scale with 0.01-g precision. The dry mass of sample was then divided by its volume to determine the dry bulk density (ρ_{dry}). Average bulk density for the four samples was 1.43 g/cm³ (range: 1.29 to 1.53 g/cm³). The impounded sediment was relatively homogeneous in both the horizontal and vertical directions (Richard Ortt, personal communication; Interfluve, Inc., unpublished data, 2009), similar to that observed using a more detailed bulk density sampling strategy at MVD (Pearson *et al.*, 2011).

surveys were estimated via repeat morphometry surveys using a combination of the monumented cross-sections and DEMs (Section 3.1). For example, the Simkins impoundment extends upstream of XS-1 for a distance of about 230 m while its extent downstream is covered by a DEM (Figure 3b). Thus, to estimate ΔS_{us} we had to: (1) difference successive XS-1 surveys and extrapolate the change in cross-sectional area at that location by multiplying it over the upstream channel centerline distance to estimate volumetric change; (2) difference successive DEMs; and (3) add the two volumetric change estimates to obtain a total volume, which was converted to mass via our bulk density estimate. ΔS_{ds} for each time interval was computed similarly by combining DEM differencing with cross-section extrapolations for the free-flowing channel not covered by the Bloede impoundment DEM (Figure 3b).

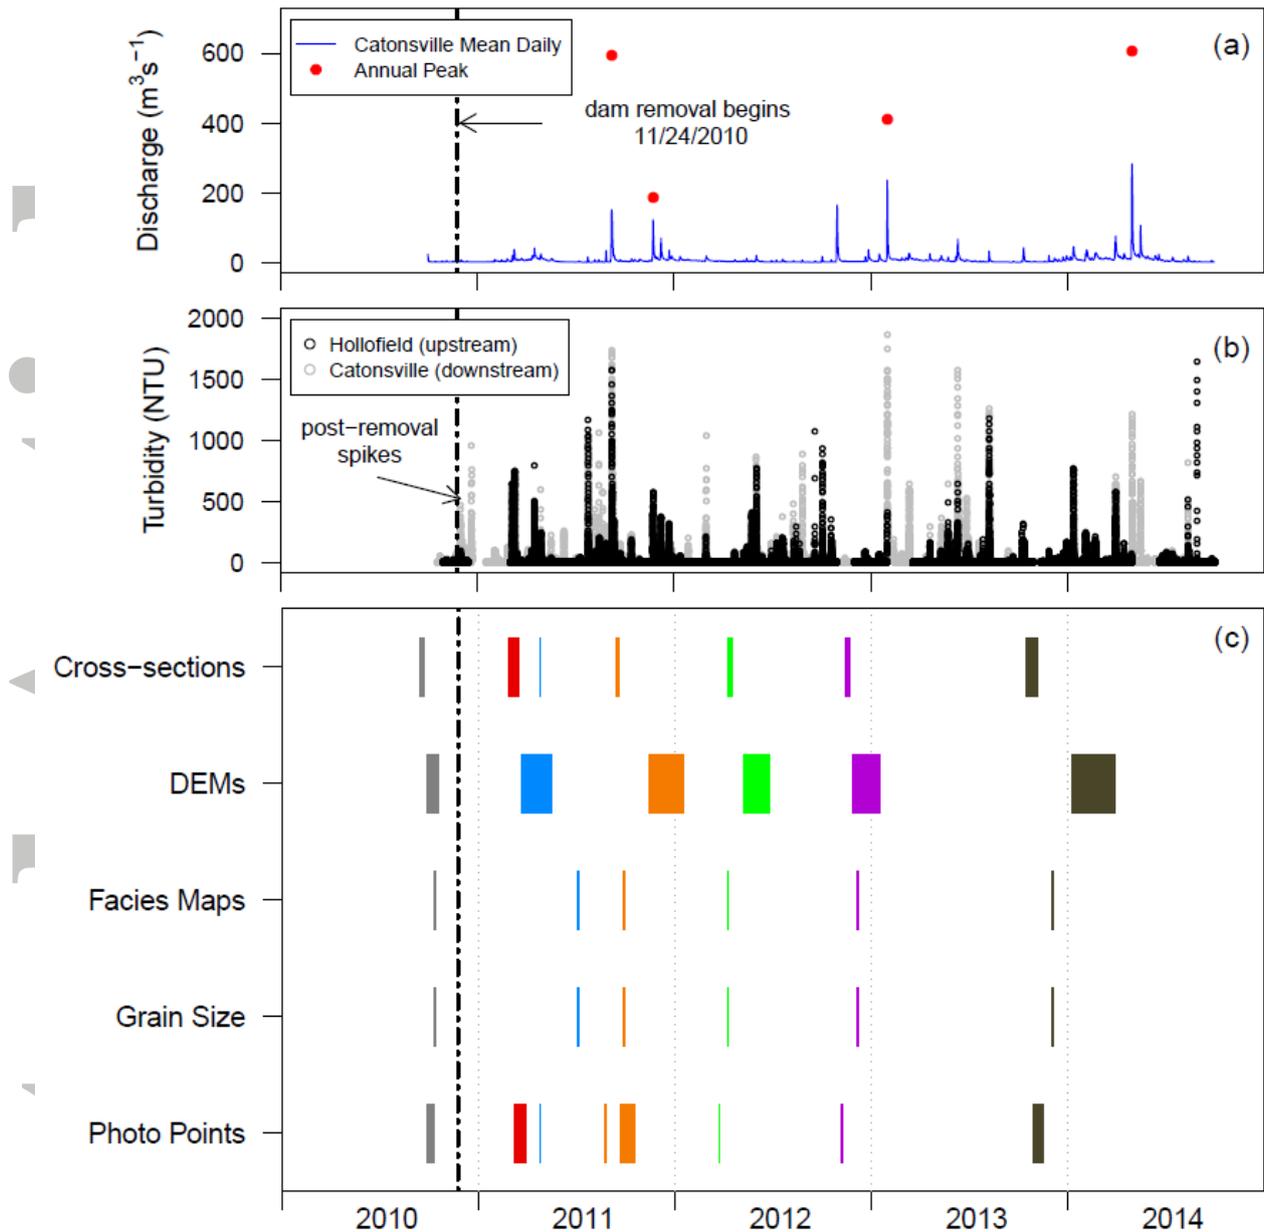
Figure 4: (a) Patapsco River hydrograph, (b) turbidity time series, and (c) morphometry data collection schedule. Field campaigns in lower panel are named by the month and year monumented cross-section surveys began: September 2010 (grey); February 2011 (red); April 2011 (blue); September 2011 (orange); April 2012 (green); November 2012 (purple); November 2013 (dark brown). For the April 2011 campaign (blue), cross-sections and photo points were collected only at a subset of the fixed stations for these parameters (XS-1 through XS-17); facies maps and grain size samples were not collected until July 2011. Turbidity time series shown in (b) are also shown in *Tullos et al.*, 2016.

Cross-sections were surveyed once before and six times after removal (Figure 4). Post-removal survey frequency was greatest in the first year after removal (three surveys in 2011) to document rapidly changing conditions in the winter and spring and the response to a large flood event on September 7 associated with Tropical Storm Lee. We estimate that event had a recurrence interval of approximately 10-years based on the Hollofield annual flood series. Survey frequency progressively decreased in successive years. Survey points were taken at significant slope breaks, edge of water, and at locations delimiting significant geomorphic features such as bars, bank toes, bank tops, etc. To supplement the quantitative data, we took repeat photographs at fixed azimuths up-, down-, and cross-stream from each cross-section monument and at over 60 additional fixed stations in the monitoring reach (not shown). Repeat photos were taken contemporaneously with cross-section survey campaigns.

Discharge and turbidity data were collected at three gage sites beginning in October 2010 (Figure 4): above the project reach (Figure 1), below the Simkins site, and approximately 5 river kilometers below Bloede Dam near XS-16 (Figure 3b and c). The Hollofield gage upstream of the study area was restarted on October 1, 2010, in association with this study. On the same date the Catonsville gage and USGS gage 01589035 (Patapsco River near Elkridge, MD, hereafter “Elkridge”) were established in the reach below Simkins Dam. At these stations discharge is estimated by standard USGS methods from stage measurements every 15 minutes (Rantz, 1982). Turbidity is also measured every 15-minutes using a Forest Technology Systems DTS-12 turbidity sensor. The sensor reports nephelometric turbidity units (NTU) with a dynamic range between 0 and 1,600 NTU. Discharge and

Figure 4b shows that the Simkins Dam removal temporarily elevated turbidity at the Catonsville gage above levels recorded simultaneously at the Hollofield control gage. However, the comparative turbidity records also show that the turbidity spike shortly after dam removal was of a similar magnitude and duration to turbidity peaks produced at both gages by watershed stormflows unaffected by dam removal.

Hollofield turbidity is unaffected by the dam removal throughout the period shown in Figure 4b and the removal's influence on turbidity at Catonsville probably does not extend beyond 2011.

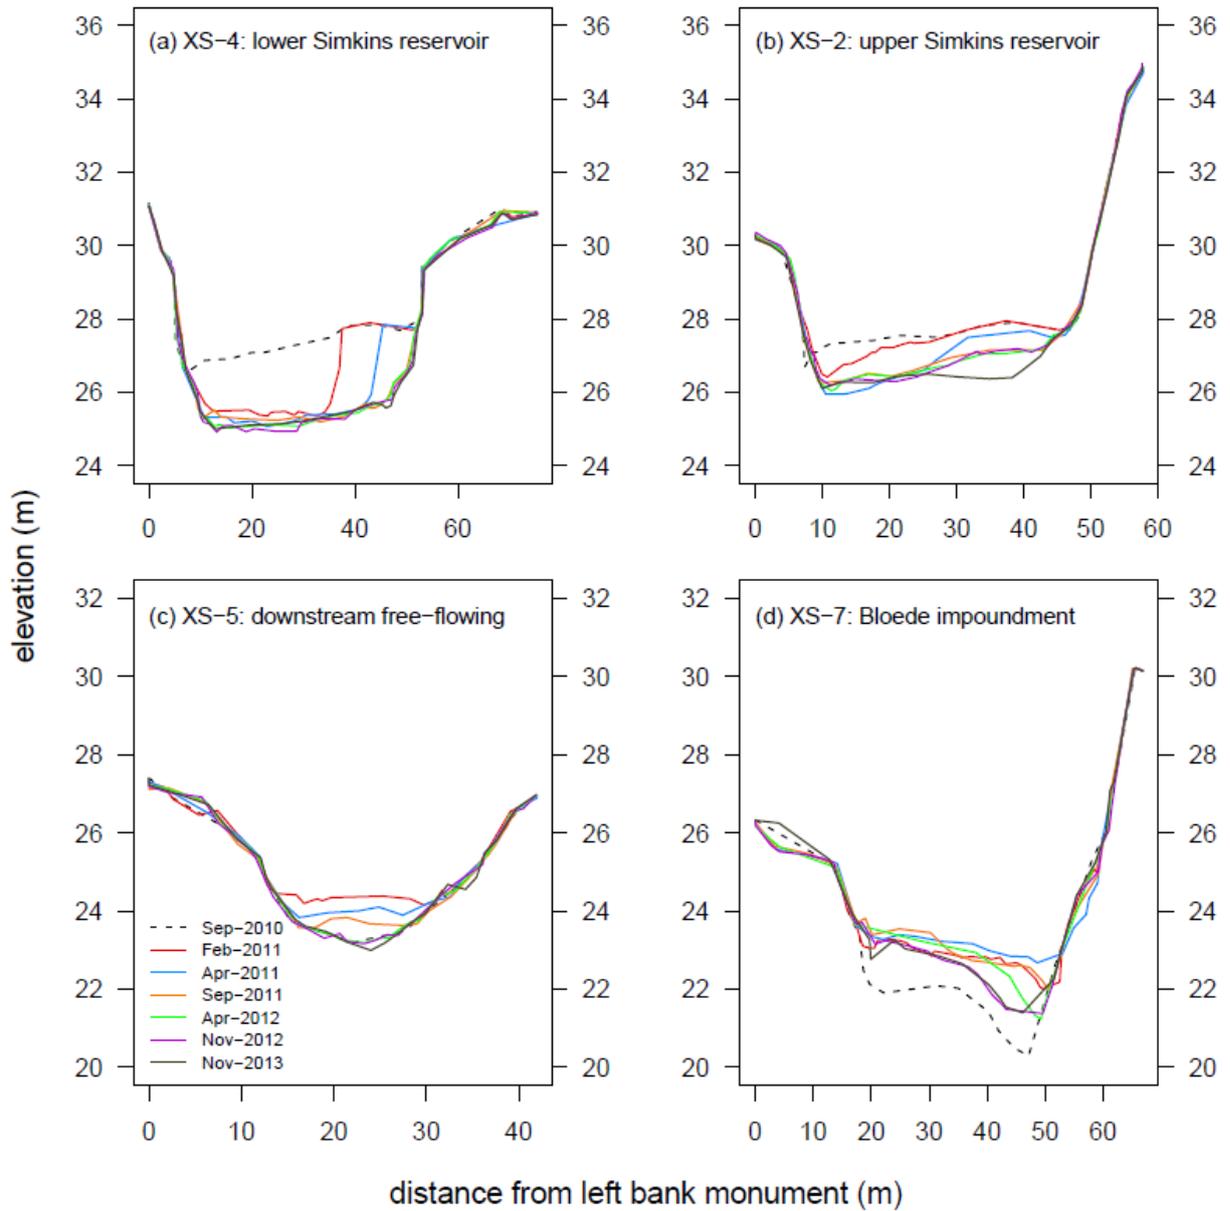
Figure 5: Example cross-section changes in the Simkins impoundment (a and b), the free-flowing reach immediately downstream (c), and the Bloede impoundment (d).

Vertical datum is NAVD88.

The dominantly sand-sized sediments that were rapidly eroded from the Simkins impoundment during the first three months following dam removal aggraded the free-flowing reach immediately downstream and the upper Bloede impoundment by as much as 1.5 m over the same period (Figure 5c and d). Inspection of the

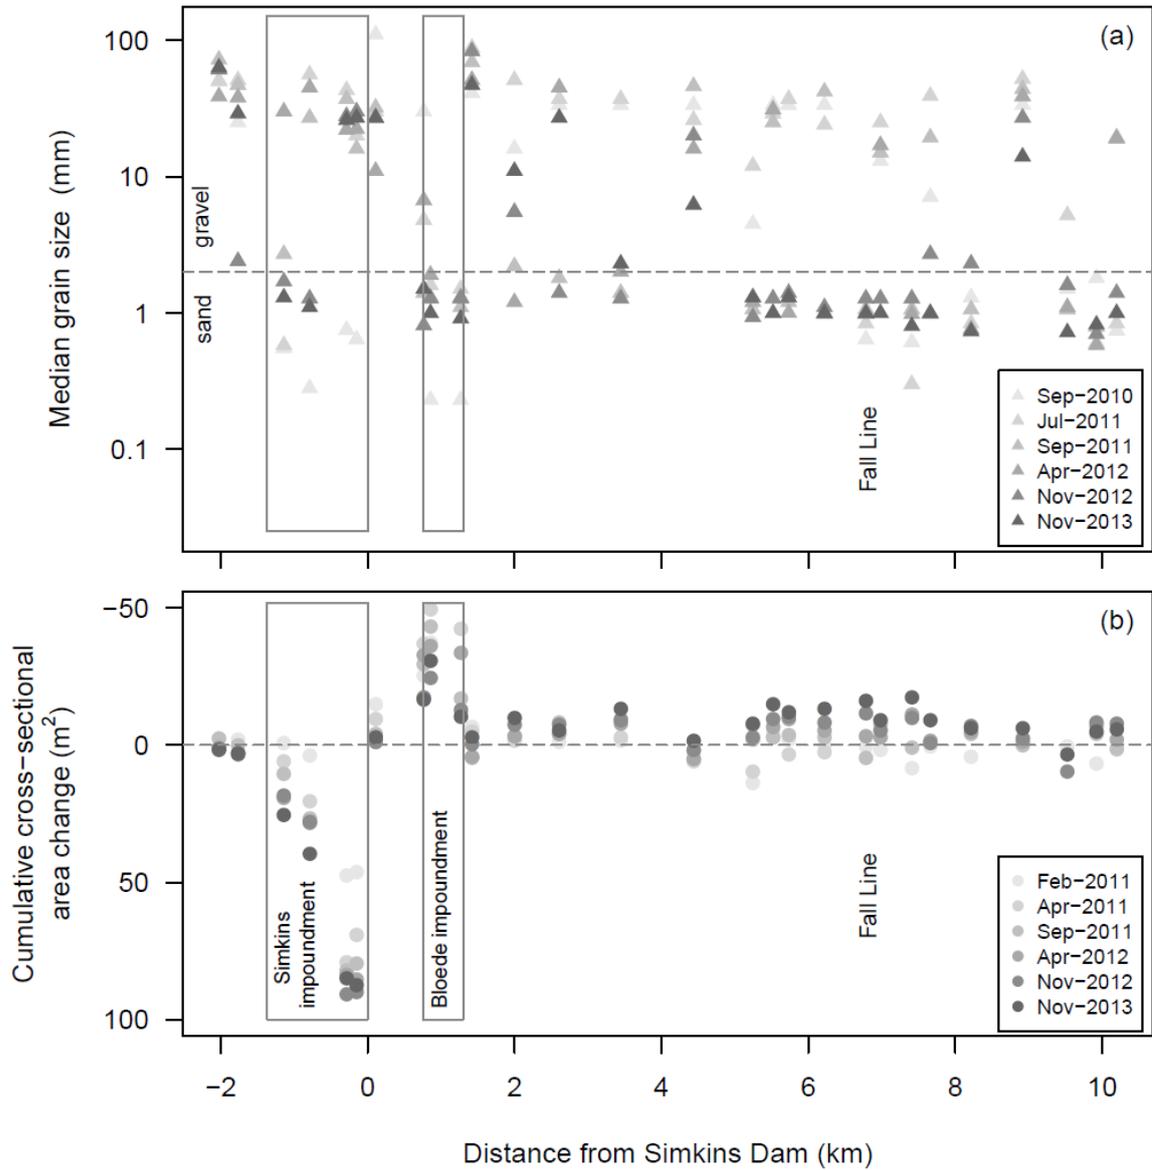
Figure 6: Temporal evolution of (a) dominant median grain size (D_{50}) and (b) channel capacity at the 28 monumented cross-sections throughout the Patapsco study area. Positive (negative) cumulative changes in channel cross-sectional area indicate the cumulative area of erosion (deposition) at a section.

Figure 6a shows persistent coarsening from sand-size to pebble-sized D_{50} for the dominant facies of the lower two cross-sections. The D_{50} of the dominant facies in the upper impoundment also increased from medium sand to pebbles, but late in the study period these upper reaches were modestly aggraded with finer materials from farther upstream so that coarse sands were the D_{50} of the dominant facies by November 2013.

Channel bed texture ranged widely throughout the study period immediately downstream of the Simkins Dam site as the cobble bed was first aggraded with sand and subsequently re-exposed (Figure 6a). The full range of texture change at XS-5, the first section below the Simkins Dam, was not captured quantitatively because our first post-removal facies mapping and sediment sampling did not occur until July 2011. By that time, the D_{50} of the dominant facies was back in the gravel range because some coarser bed materials were rapidly re-exposed by erosion of the sand (Figure 5c). Texture change in the Bloede impoundment was generally smaller. XS-6, at the upper boundary of the impoundment, fined considerably from a pebble-sized D_{50} to coarse sand, but farther downstream the changes were more modest with a shift from fine-medium sands to coarse sands (Figure 6a).

The Tropical Storm Lee flood of 7 September 2011 moved Simkins reservoir sediment downstream of Bloede Dam, leaving an irregular mantle of sand, most persistently in the reach near the Fall Line where the channel gradient flattens from 0.002 to 0.0004 (5-8 km downstream of Simkins Dam; Figure 6a and b). Cross-sections here (not shown) and DEMs (Figure 3c) recorded about 0.3 m to a maximum of about 1 m of aggradation over the study period and D_{50} of the dominant facies shifted from pebble-sized to coarse-very coarse sands (Figure 6a). Farther downstream in the sand-bedded, Coastal Plain reach, aggradation was more modest and at one section there was minor net degradation (Figure 6b). Changes in D_{50} of the dominant facies were also more modest and variable, with most sections beginning and ending the study period in the sand range (Figure 6a).

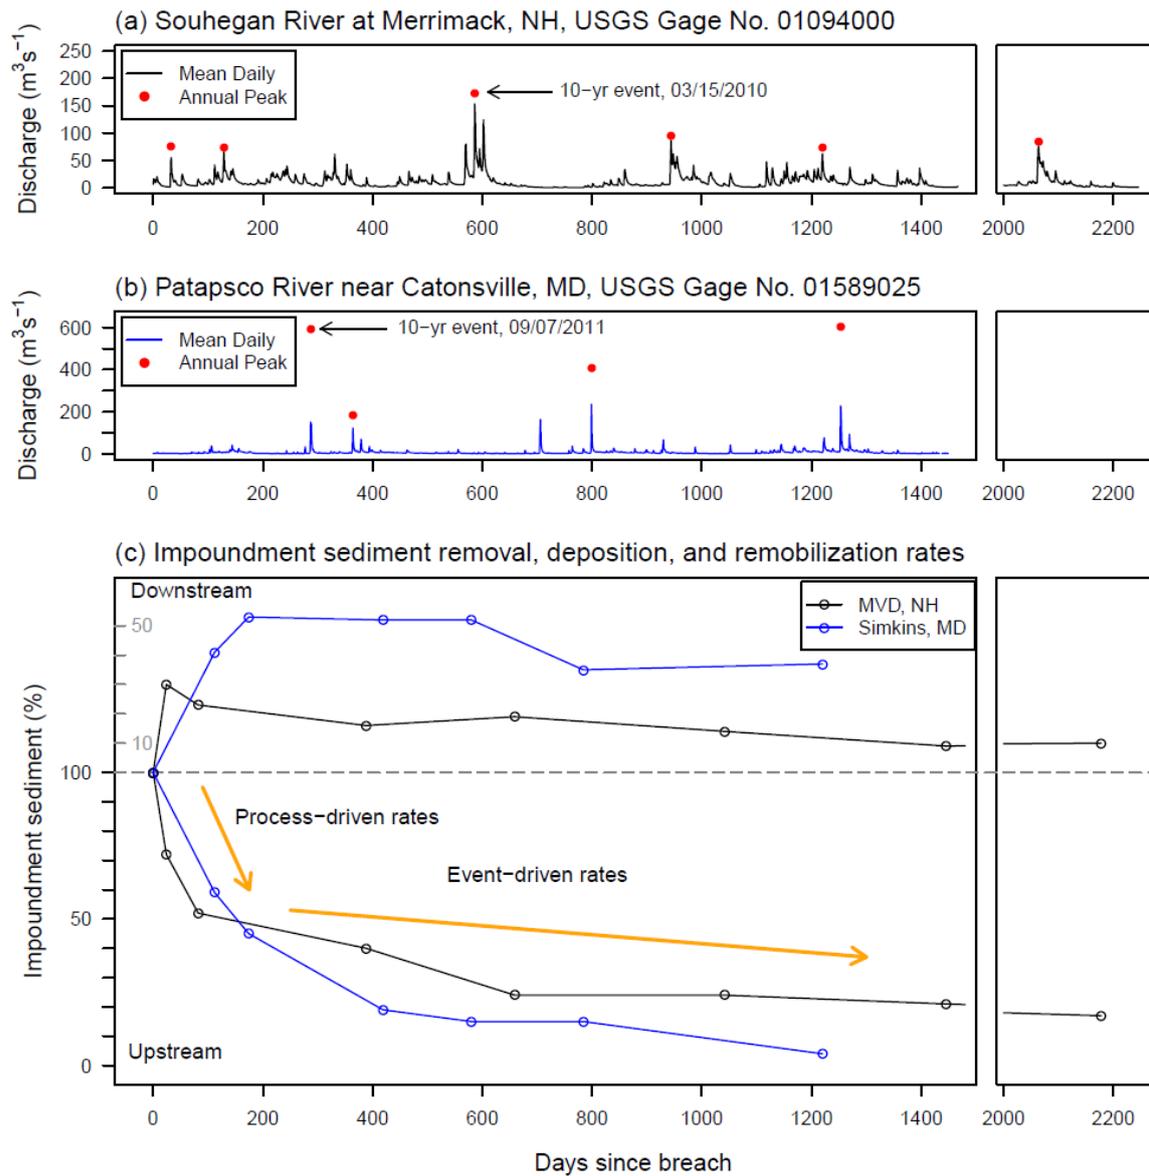
Figure 7: Post-removal hydrographs for the MVD site (a) and Simkins Dam site (b) along with their comparative erosion, deposition, and remobilization rates (c). Simkins erosion data in (c) also shown in review paper by Major et al. (Geomorphic responses to U.S. dam removals—a two-decade perspective, in press at *Gravel Bed Rivers* 8, 2017). MVD erosion data to ~700 days after *Pearson et al.* (2011).

Simkins Dam removal began on November 24, 2010, and in less than a week the 3 m elevation spillway was removed to base level—the pre-dam channel bed. The stored sediment incised rapidly to nearly base level in the lower impoundment, as recorded by the first post-removal survey at XS-4 in February 2011 (Figure 5a). In the upper impoundment, incision was slower but nonetheless mostly complete at XS-2 by April 2011 (Figure 5b). Incision was accompanied, or succeeded, by channel widening throughout the impoundment. Rapid erosion is also evident in plots of cumulative cross-section area change (Figure 6b) and the bed material budget, which shows that over 40% of the impounded sediment was eroded within about three months (Table 2). Erosion rates during this period, a time of very low flows on the river (Figure 7b), were more than 60% greater than any other time interval (Table 2). Erosion rates remained substantial through the September 2011 survey, by which time more than 80% of the total stored sediment had been eroded from the impoundment, aided by an approximately 10-year recurrence interval event on September 7 associated with Tropical Storm Lee (Figure 7b). Episodic erosion

sediment budget shows that virtually all of the sediment eroded by February 2011 was trapped in this reach (Table 2 and Figure 7c). Between February and April 2011, additional sediment was released from the Simkins impoundment and some sediment that had aggraded in the free-flowing section in the first three months (Figure 5c) was remobilized and redeposited in the Bloede impoundment (Figure 5d) by small storms and base flows. Tropical Storm Lee in September 2011 accelerated sediment redistribution in the reach and transported the first substantial quantity of Simkins sediment over Bloede Dam (Table 2, Figures 5c-d, 6b, and 7b). Outputs over the dam in successive surveys reflected modest erosion from the Simkins impoundment and remobilization of sediment stored temporarily above Bloede Dam (Table 2 and Figure 6b). By April 2012, erosion in the free flowing reach above the Bloede impoundment had reestablished the pre-removal channel dimensions (Figure 5c and 6b) but a significant quantity of Simkins sediment remained stored in the Bloede impoundment by November 2013 (Table 2, Figure 5d and 6b).

leads to end-member transport-limited conditions as a new channel forms. The Simkins site demonstrates this phenomenon particularly well given the small discharge in the first few months after removal (Figure 7b).

The Simkins erosion data generally indicate the change in process that characterizes the two-phase erosion model proposed by *Pearson et al.* (2011) for MVD. But it is not obvious from Figure 7c that the two erosion curves are not instead exhibiting continuous exponential decay with a single rate constant. To evaluate this, in Figure 8 we replot the erosion data for the MVD and Simkins impoundments and fit to the respective data series single-phase, non-linear least squares exponential models of the form:

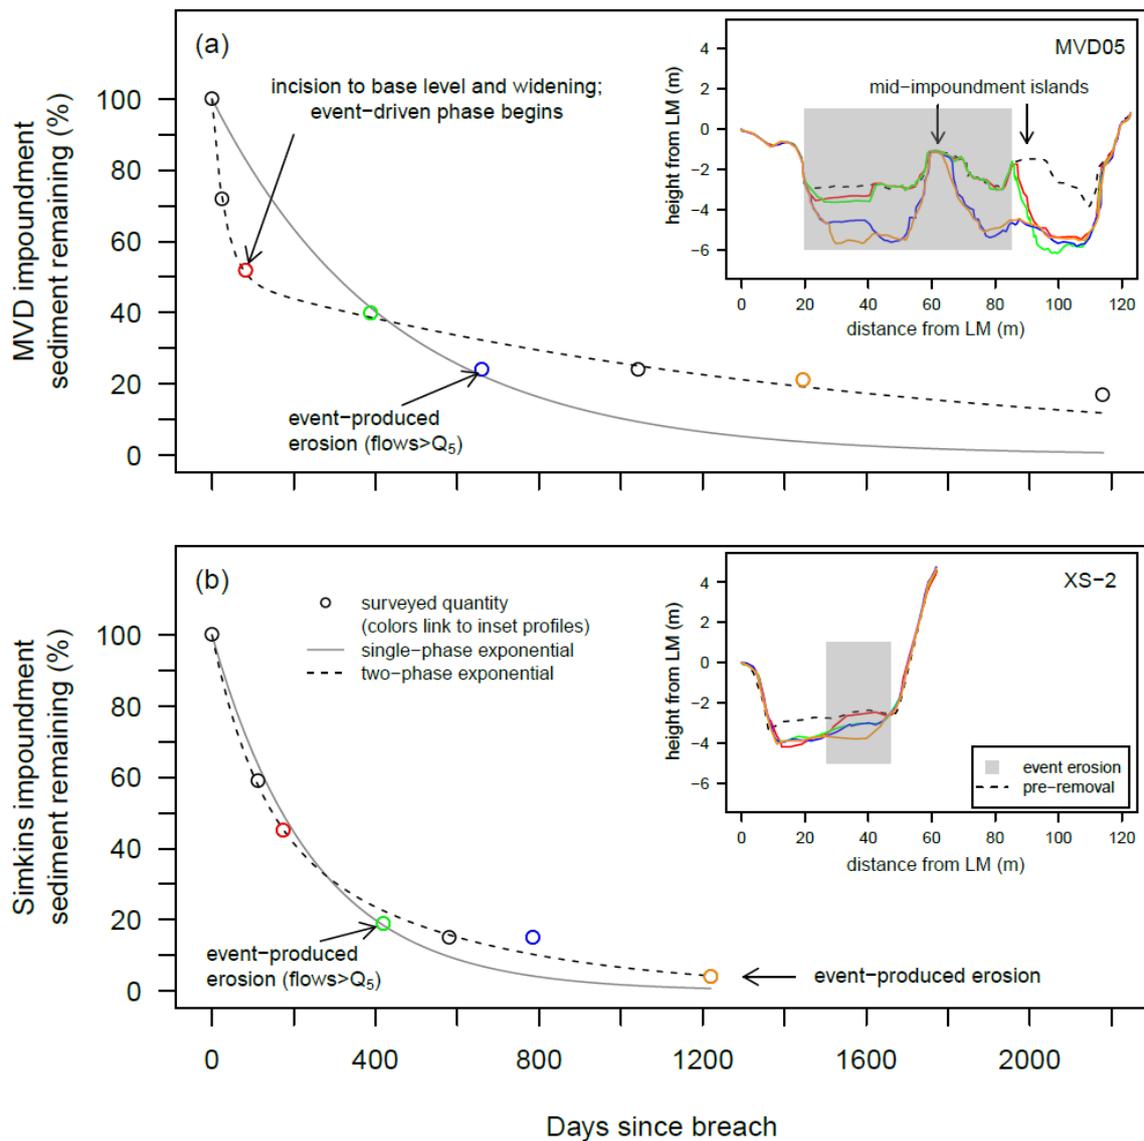
Figure 8: Measured quantities of impoundment sediment remaining with time (as in Figure 7c) plotted with single- and two-phase non-linear least squares exponential models fit to the data series. Colored data points correspond in time with profiles for representative cross-sections shown in the insets, where “LM” indicates “left monument”. (a) MVD impoundment. (b) Simkins impoundment. The two fitted models for each site, and measures of their comparative fit, are shown in Table 1.

$N(t)$ is the quantity of impounded sediment remaining at any given time, t , in percent. N_0 is the intercept, or the quantity at $t=0$, which was set to 100% for each site to represent the sediment quantity impounded at the time dam removal began. As shown by *Pearson et al.* (2011) using a different fitting algorithm, the continuous exponential model (solid grey) appears to fit the MVD data poorly (Table 1 and Figure 8a). It underpredicts actual erosion in the early post-removal period and overpredicts later in the period. The single-phase exponential model fit to the Simkins data does a better job, especially for the early post-project period, but it also overpredicts the later stage (Table 1 and Figure 8b).

The two-phase model is clearly better than the single-phase model for the MVD data (Table 1 and Figure 8a). The process shift when base level is attained is manifest in an order of magnitude decrease in the decay constant from the first to second phase. Although the second phase of the model does not fit the data as well as the first phase, the residuals have a straightforward interpretation. Negative residuals (greater than expected erosion) follow intervals with erosion-producing events ($>Q_5$). Periods without events are characterized by successive data points that typically end with positive residuals (less than expected erosion; see period 1,000 to 2,200 days since breach on Figure 8a). Erosion during the event-driven phase is episodic and depends on the arrival rate of large discharges.

has a substantially improved fit compared to the single-phase model (change in AIC of 10; Table 1) and the same general pattern is evident: the decay constant decreases by 75% from the first to second phase and we see a second phase fit that is poorer than the first phase fit (Figure 8b). The event-phase residuals have the same interpretation as they do at MVD: negative residuals follow erosion-producing events and periods without events are characterized by successive data points ending with positive residuals (period 580 to 800 days since breach on Figure 8b).
